# Gillspeed Express Delivers Parts To Your Door.

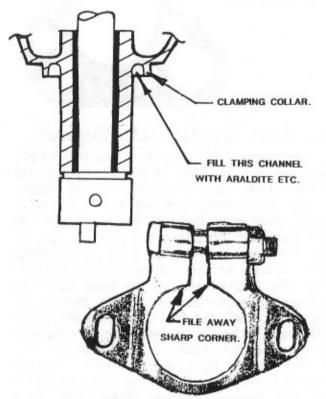
If Lucas distributor clamps are over tightened they often distort the weak clamping collar on the distributor body. Eventually part of the collar breaks off allowing the distributor to come adrift and stop the engine. To overcome these problems, turn the distributor body upside down, push the collar back into shape with a screwdriver and fill the channel with a liquid metal or Araldite to give it more strength: If pieces are broken off, you can have someone machine away the broken section then machine up a replacement alloy collar and shrink it on. Finally, you can bend the clamp back into its correct shape and file the inside of the clamp as shown in the sketch. This will reduce the chance of further damaging your distributor body.

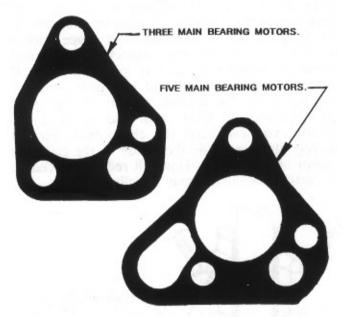
Every now and then, someone rings up asking why they cannot build up oil pressure in their rebuilt MGB engine. The problem almost always boils down to someone having fitted the wrong gasket between the oil pump body and the cylinder block. Early 'three main bearing' MGB motors and later 'five main bearing' MGB motors have different gaskets! They are shown below. If the wrong gasket is fitted the oil pump ends up sucking air as well as oil. The sketch below shows the two gaskets.

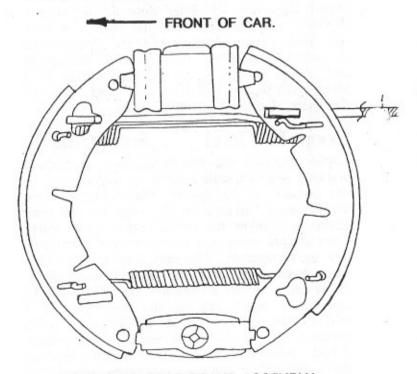
LEFT HAND REAR BRAKE ASSEMBLY.

The Sprite and Midget factory workshop manual does not have a clear drawing of the correct way to assemble the rear brake shoes and retractor springs, so here it is.
